Keeping the Bedroom Cool – Using EHP Rollboard Insulation

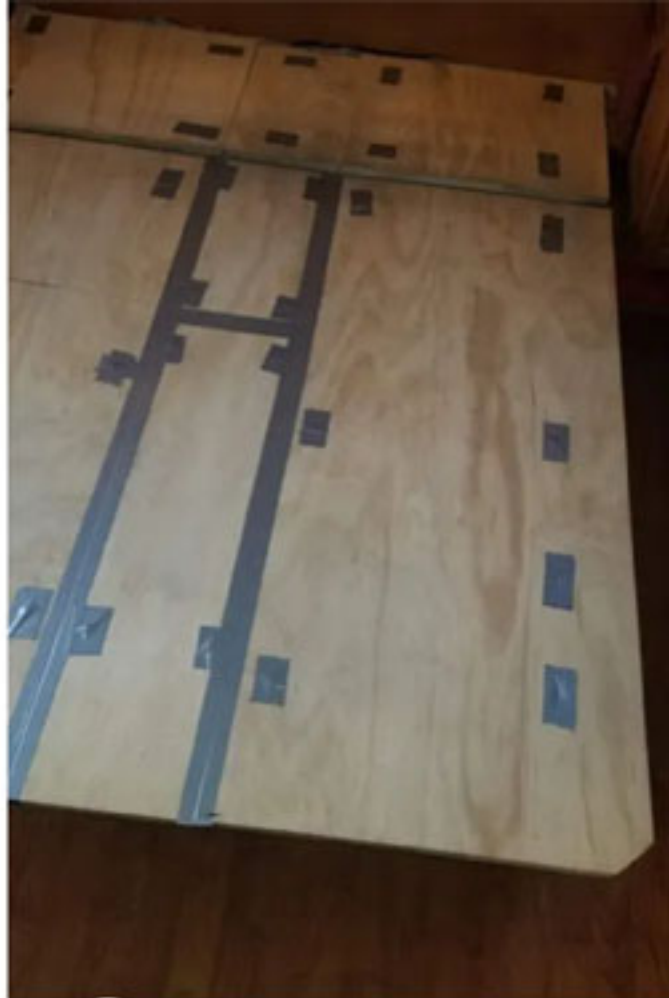
Plywood over the original base that extended out about 6" on three sides. Duct tape covered the screw heads.

I had to modify my bed to extend the platform so that it would support the entire mattress. Even though I retained a queen-size bed, without a built-in box spring, I had to support the mattress all the way to the edges. I did that by buying one sheet of 5/9" plywood and with a few cuts and some screws, I had the entire surface below my air mattress covered.

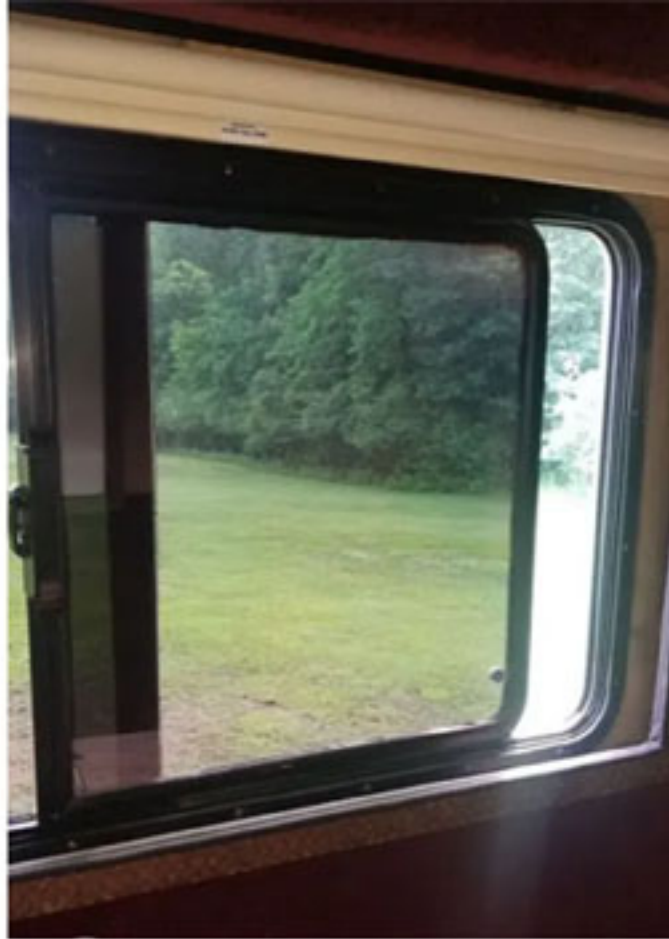
Slightly open bedroom window whilst driving.

I found that driving with the bedroom windows open helps to dissipate the engine heat so the bedroom is not like a sauna when I arrive at a new destination. But even this was not enough to keep the bladders cool enough to protect the glued seams.

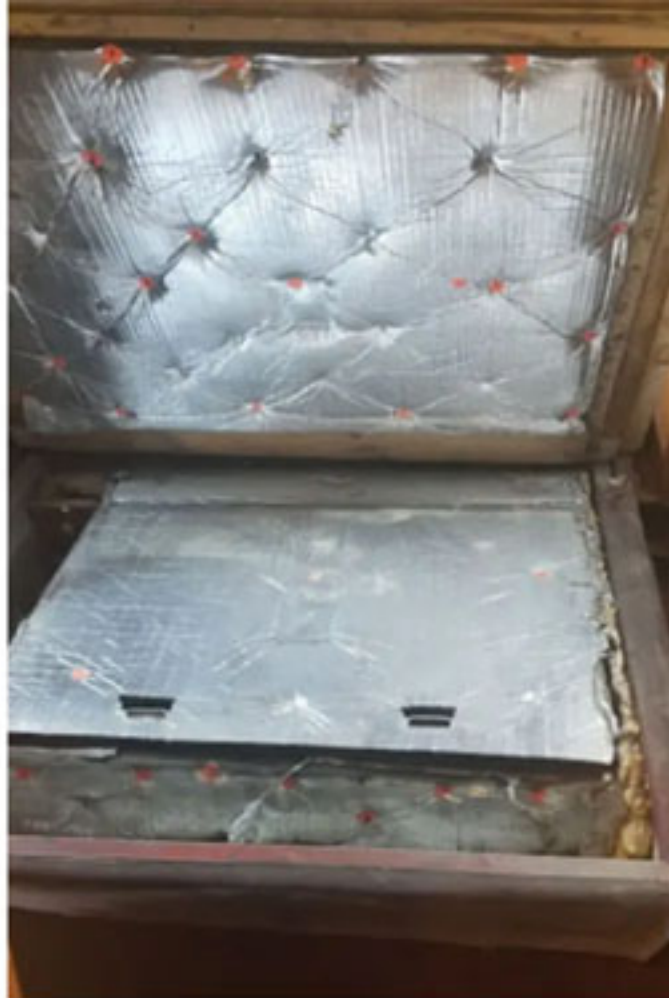
This is what the area under my bed looked like when I started. This is the old insulation. It was also covering the entire engine bay under the bedroom floor. Much of it had deteriorated and was crumbling off in small pieces.

Under my bed showing the original insulation.

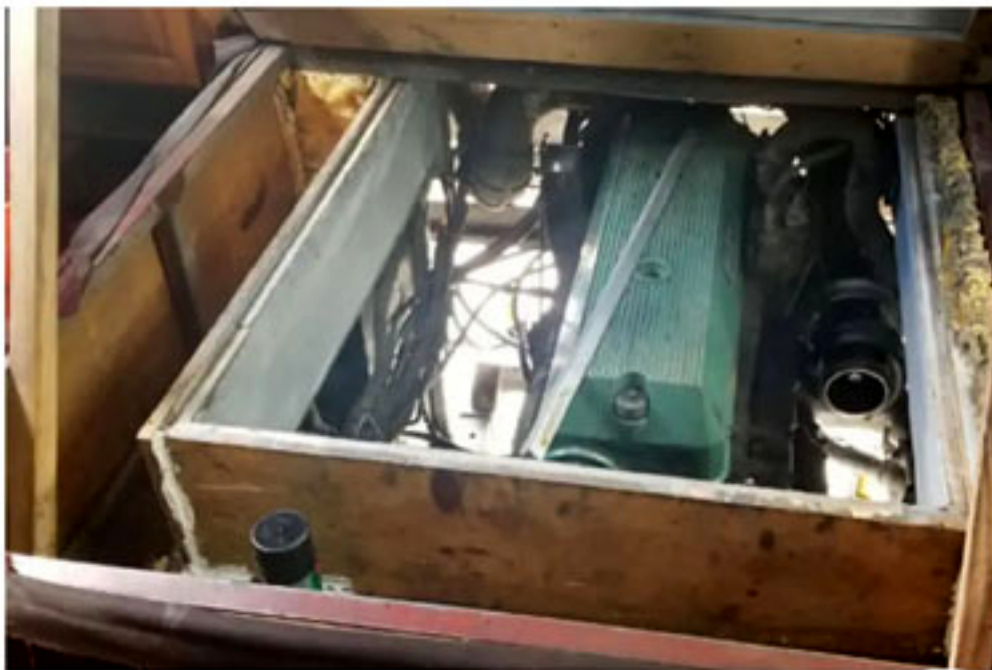
Under my bed after removing my old insulation.

I removed all of the old dusty, filthy, 25-year-old insulation that was in this area below the bed. I vacuumed the area thoroughly to prepare for the new insulation. My mechanic was also working on my engine at the same time, so I had to be careful not to drop any old insulation into the engine compartment.

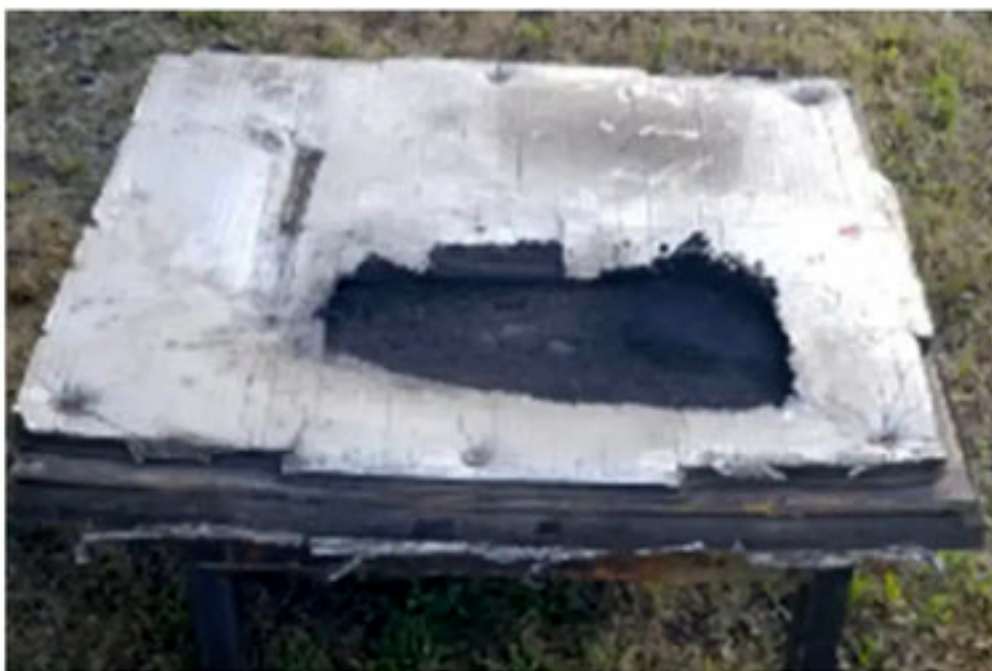
This is the underside of my engine hatch with the old insulation burned through from years of running a hot engine exhaust and turbo just a few inches away from this cover.

The previous insulation was partially destroyed by all of the heat.

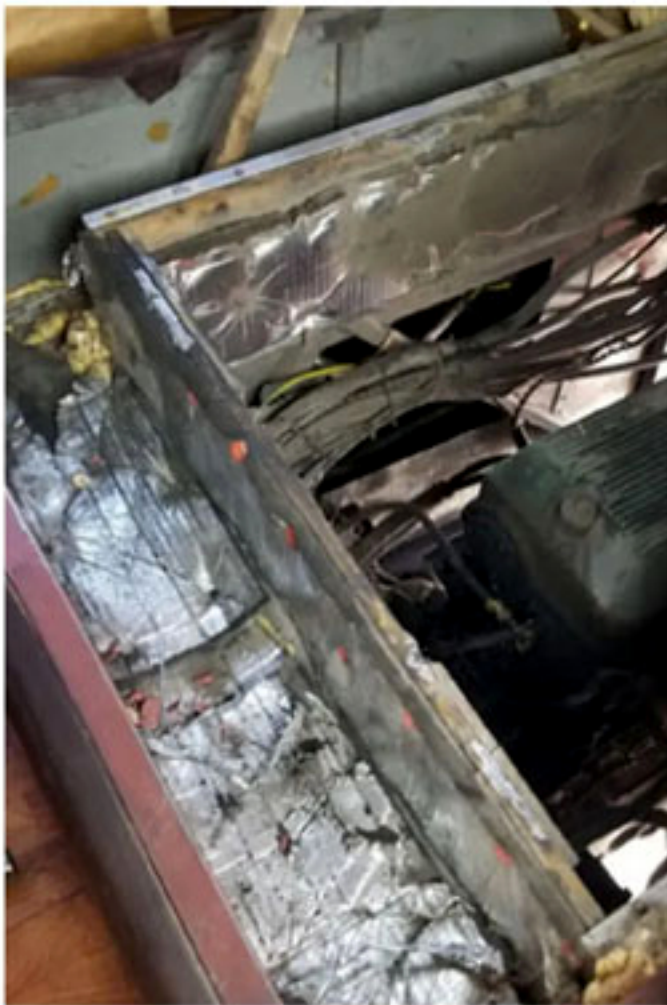
This is what I removed. This old heavy flammable insulation gives off toxic fumes when it combusts. Watch the video at the end of this article to see the difference in flammability of the old insulation vs. the EHP Rollboard insulation.

Under my bed showing the original insulation.

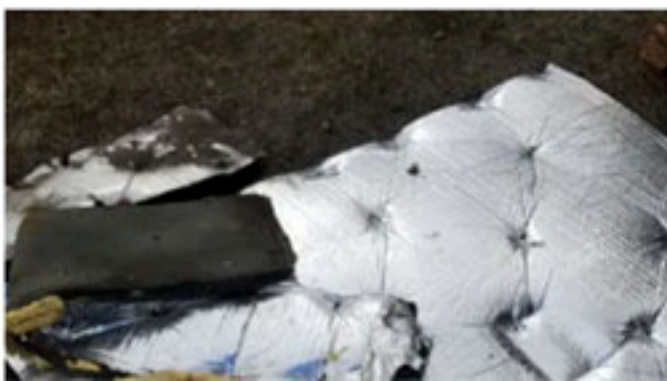
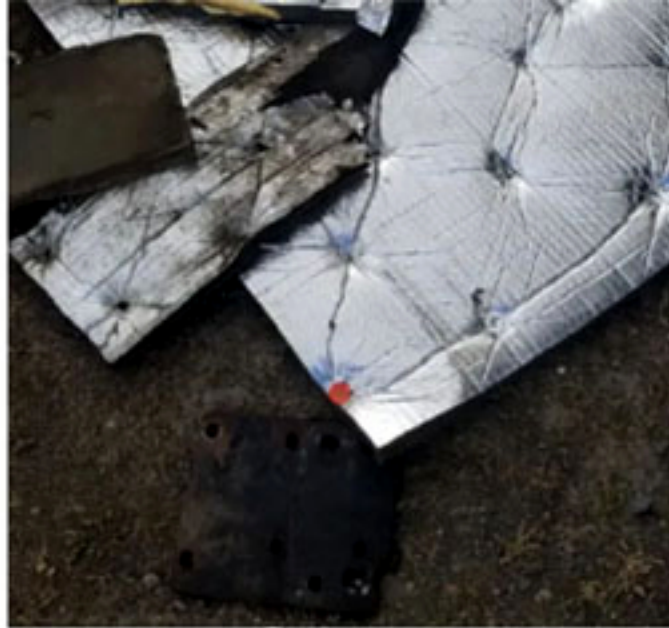
Out with the old.

I removed the old insulation from my engine hatch in preparation for covering it with Rollboard from EHP. It was glued and screwed down.

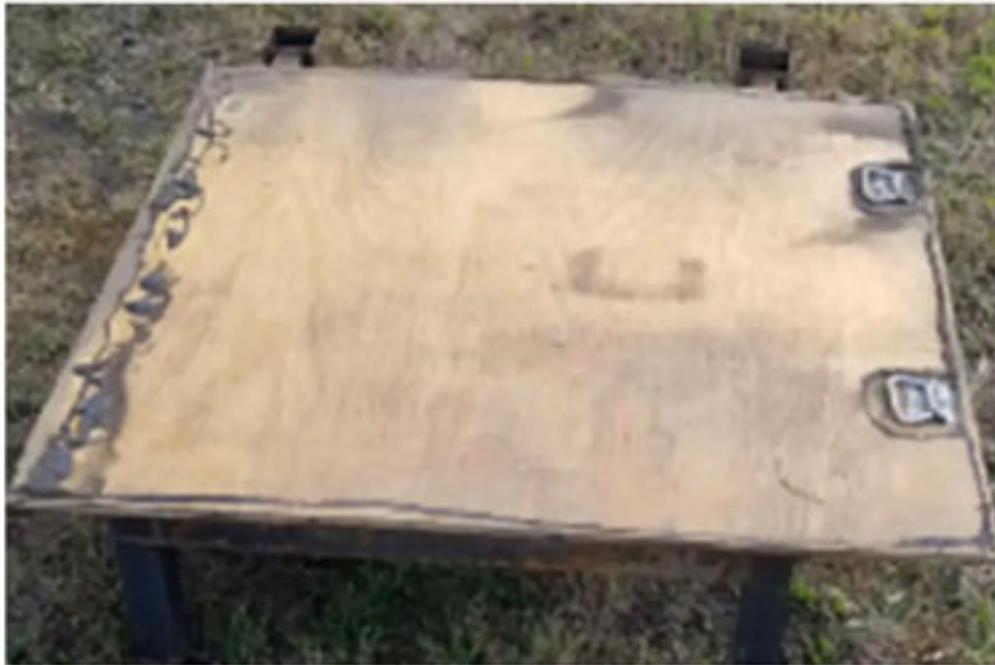
After removing the old insulation

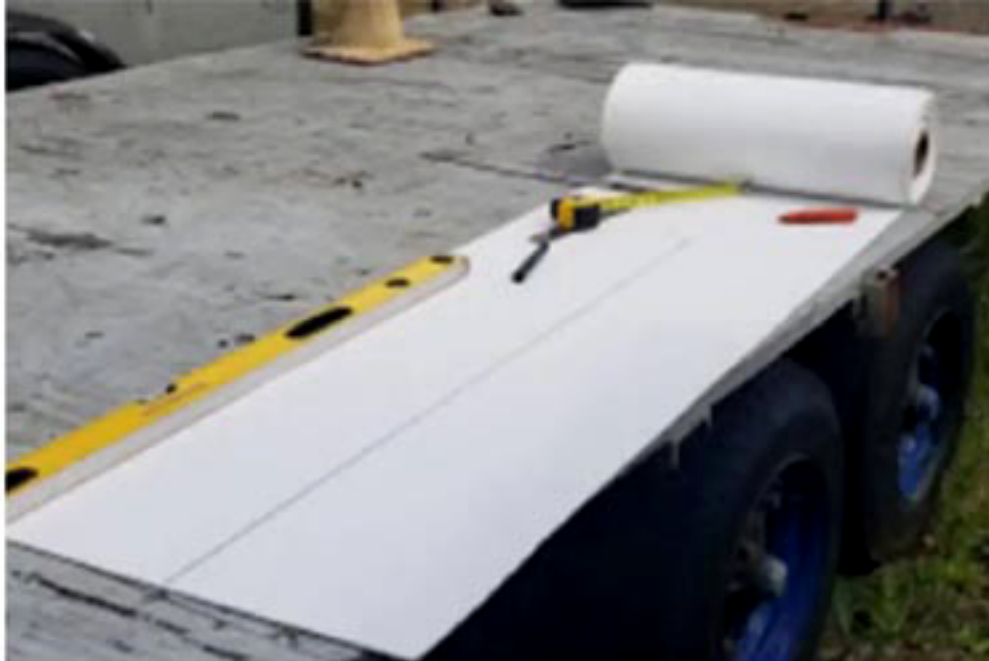
Cutting new Rollboard insulation.

I had a trailer to work on so I rolled out the new Rollboard insulation and measured new pieces to fit my entire engine compartment. It turns out that I used several square yards of the insulation to cover the entire area while cutting it to utilize the greatest number of square inches without waste.

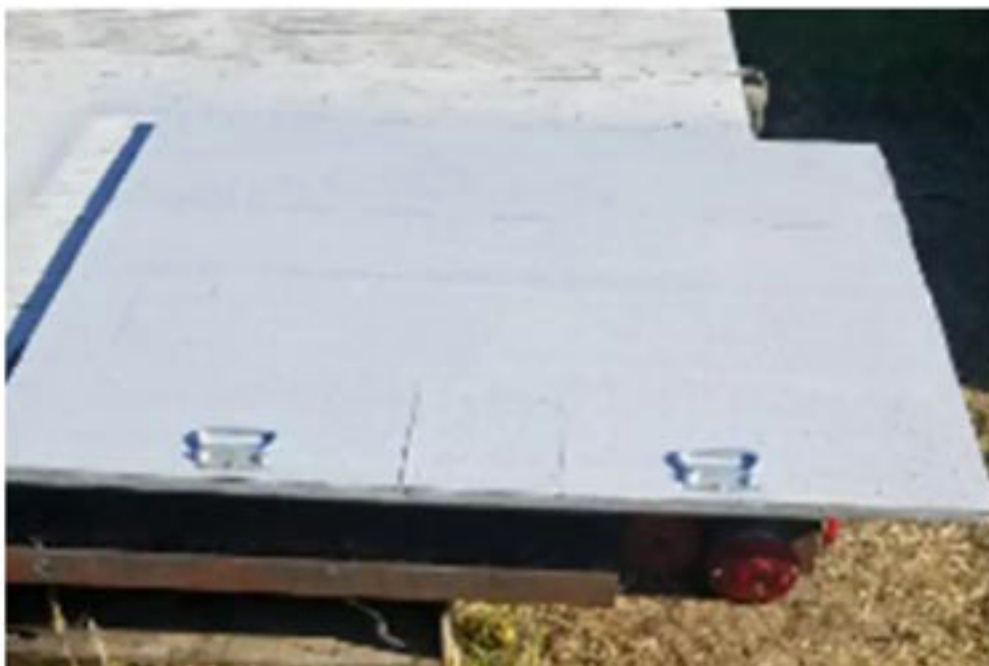
After installing new insulation. A clean new look. Note: EHP Rollboard was installed both sides of this hatch for double-insulation.

I cleaned the old plywood surface of the hatch and sprayed three layers of 3M 90 Contact Adhesive on the wood and also on the Rollboard and then glued it to the plywood. After it dried in just a few minutes, I sprayed it with a light coating of high-temperature engine paint so it would be easier to wipe off any oil or dirt that came into contact with it.

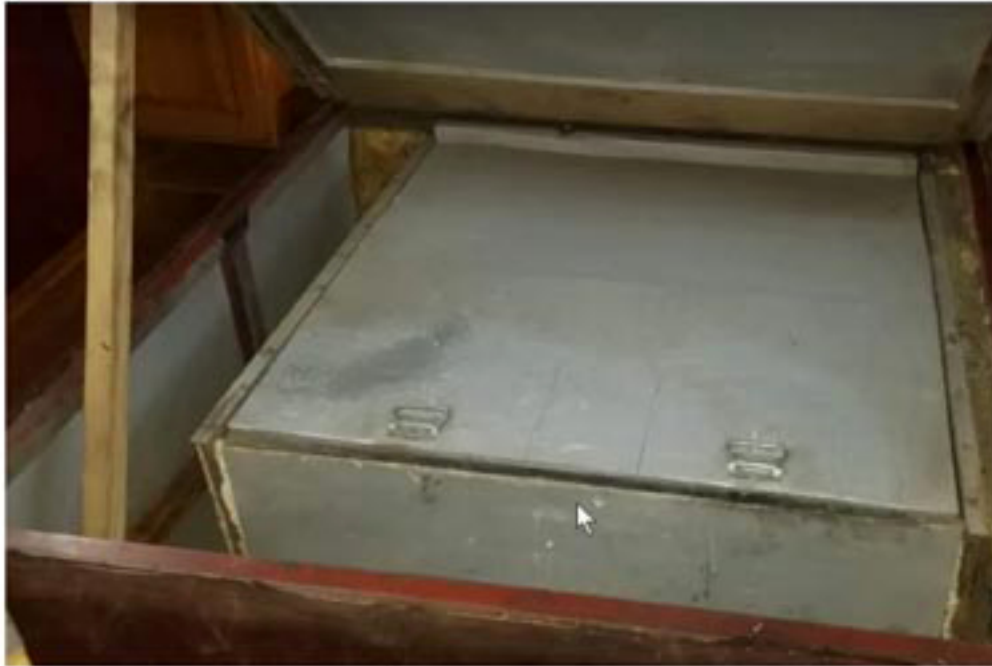
New EHP insulation glued in place.

I concluded that the heat from the engine was penetrating through my engine hatch compartment and into my bed area. This heat was affecting the glue in the mattresses causing it to break down and start leaking air over time.

It usually happened after a long pull up hills on hot days that generated an excessive amount of heat in the engine compartment. By insulating it with EHP Rollboard insulation, the heat could no longer penetrate the bed area and the air bladders have lasted over a year now with no problems. They have lasted longer than any time before I reinsulated this area since I installed the Sleep Number bed.
